Thermal Imaging Specialists

# Lightning Audit

<b>CLIENT:</b>	<b>EXAMPLE REPORT</b>
<b>SITE ADDRESS:</b>	<b>SITE NAME</b>
	<b>ADDRESS</b>
<b>DATE COMPLETED:</b>	<b>DD MM YYYY</b>
<b>REPORT PREPARED FOR:</b>	<b>CONTACT PERSON</b>
<b>ELECTRICIAN:</b>	<b>SHAUN CHALWELL – Electrician No. 135903</b>
<b>TEST EQUIPMENT:</b>	<b>FLUKE 1674FC MULTIMETER – #6644012</b>
	Calibration Due 08/01/2027

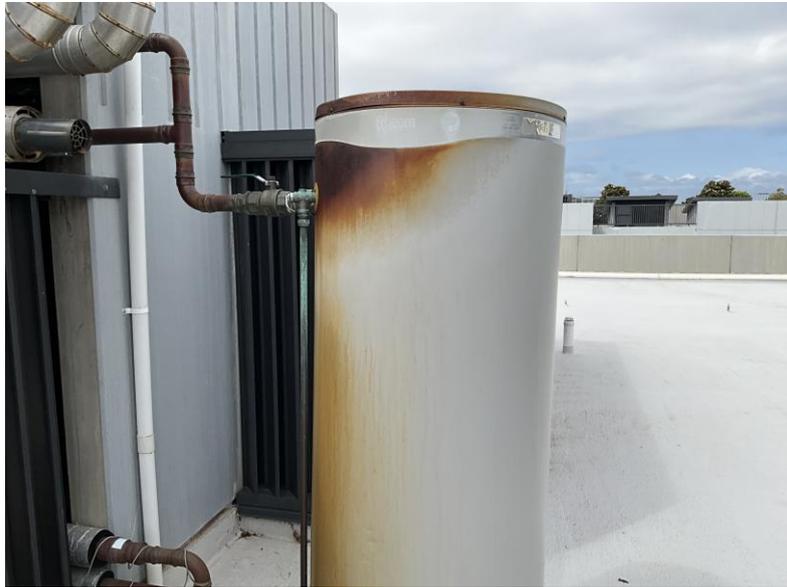
<b>Location:</b>	3 Monopoly Drive - Building A - Roof
<b>Asset:</b>	Hot Water System
<b>Comment:</b>	Evidence of Rust

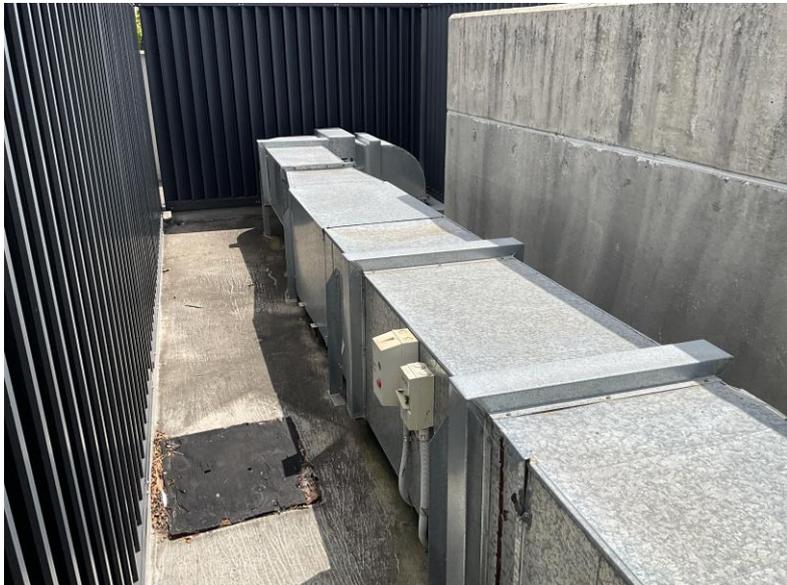
- There was no specific lightning rods or strap system in place on the buildings, however air conditioning ducts and metal objects on roof were earthed
- One air conditioning duct was found to have resistance above 10 OHMS which is the maximum allowed under AS 1768. It is recommended to investigate and enact repairs.
- The Main Switchboard had a Surge Diverter present and was operational at the time of inspection.

<b>Location:</b>	7 Sydney Way - Building C - Roof RHS from Plant Room
<b>Asset:</b>	Air Conditioning Duct
<b>Comment:</b>	Resistance was measured to be above 10 OHMS. It is recommended to investigate and install new strapping to decrease resistance to below 10 OHMS.
