Thermal Imaging Specialists

# Qualitative Inspection Report

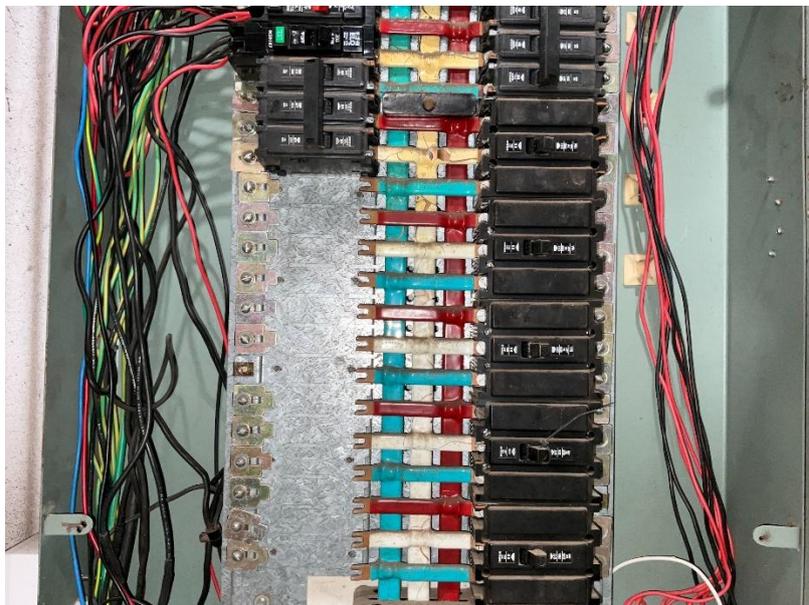
<b>Location:</b>	Warehouse - Rear Section of Warehouse
<b>Switchboard:</b>	MSB - Tier 1 - Submains
<b>Thermal Results:</b>	No thermal exceptions were found at the time of scanning

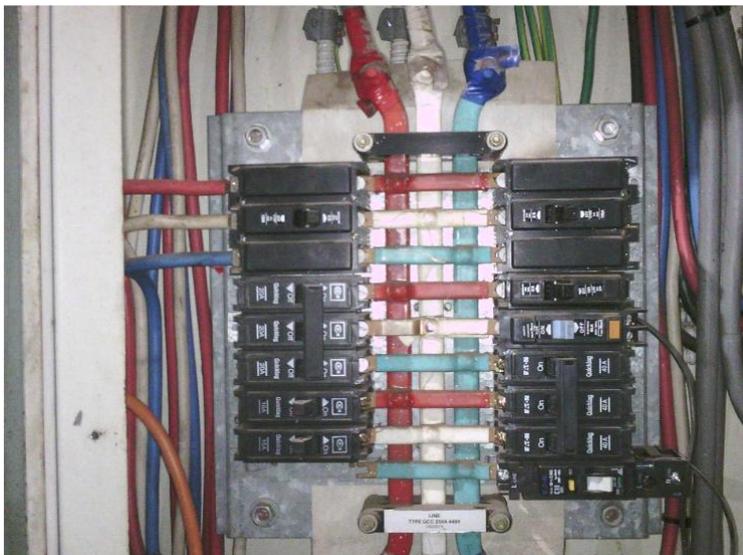
Spot A!	30.5°C
---------	--------

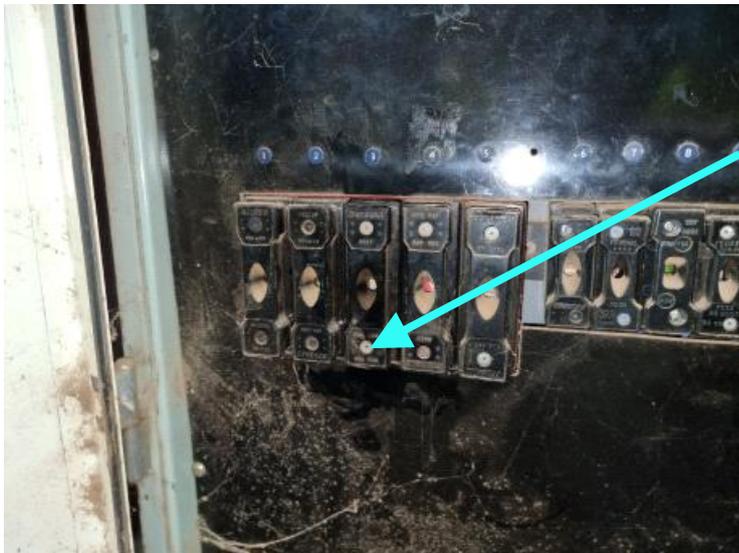
Spot A	65.5°C
Spot B	137.4°C
B-A	71.9°C

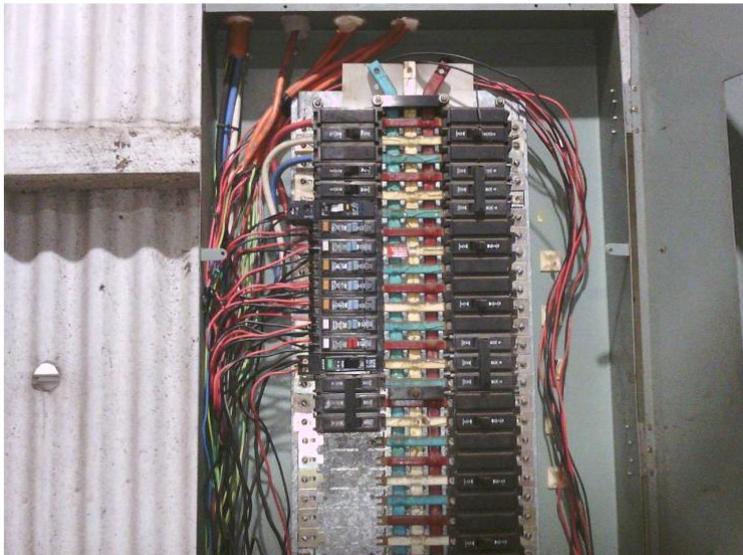
Spot A!	36.3°C
---------	--------

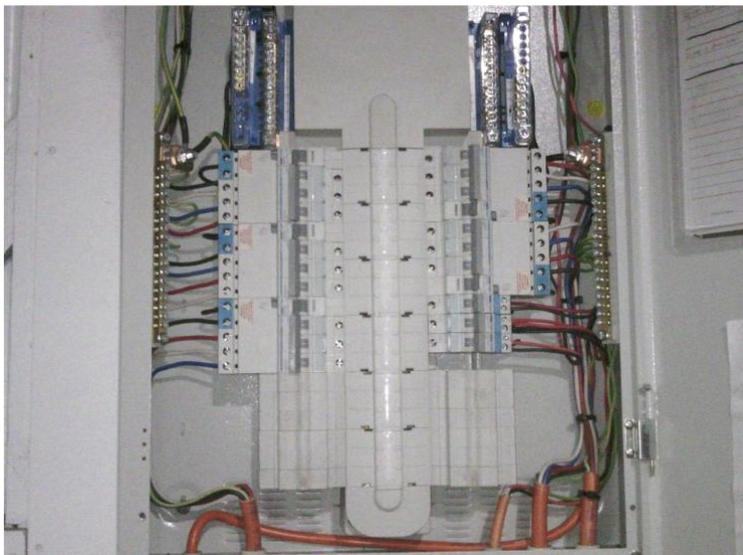
Spot A!	37.0°C
---------	--------

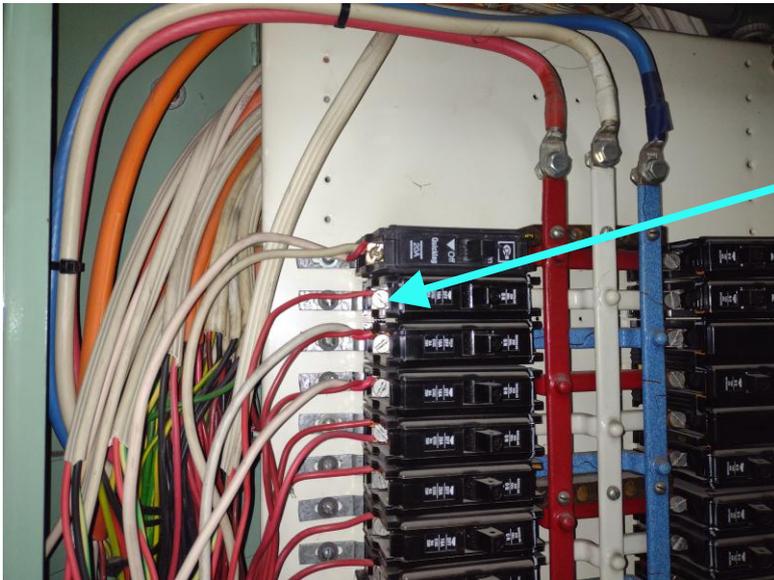
Spot A	31.6°C
Spot B	44.2°C
B-A	12.6°C

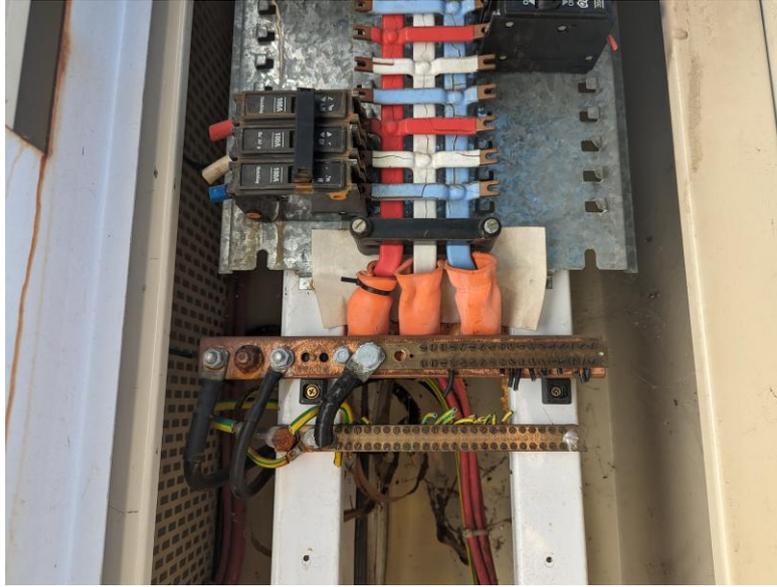
<b>Location &amp; Switchboard:</b>	<ul style="list-style-type: none"> <li><i>Warehouse - Production Area - Distribution Board D-5</i></li> </ul>
<b>Visual Exception:</b>	<i>Large amounts of dirt and dust were identified at the time of inspection. The presence of this increases the risk of an arc flash occurrence. It is recommended to clean the switchboard and investigate further remedial action to prevent dust ingress in the future</i>
